Preliminary Water Level Data (for education use):

Preliminary water level data near culverts from Back Ranch and Miwok Meadows marshes at China Camp State Park

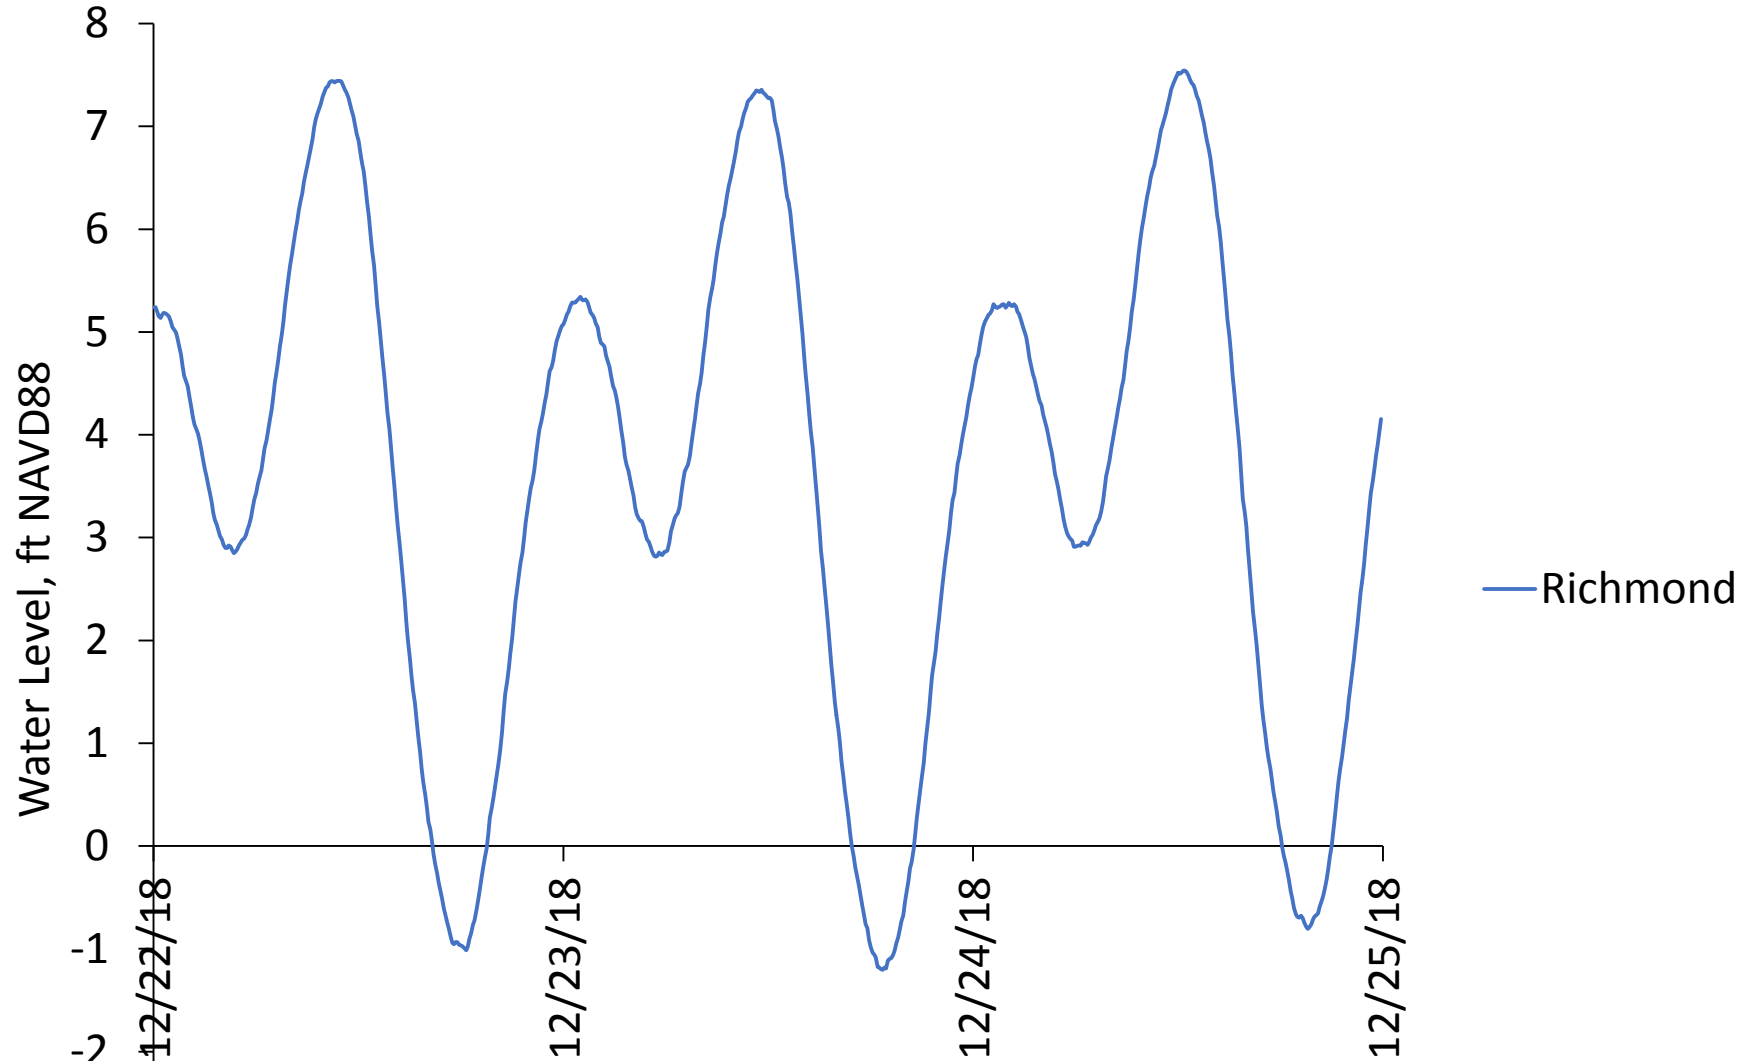
Water Level at NOAA Richmond Tide Station

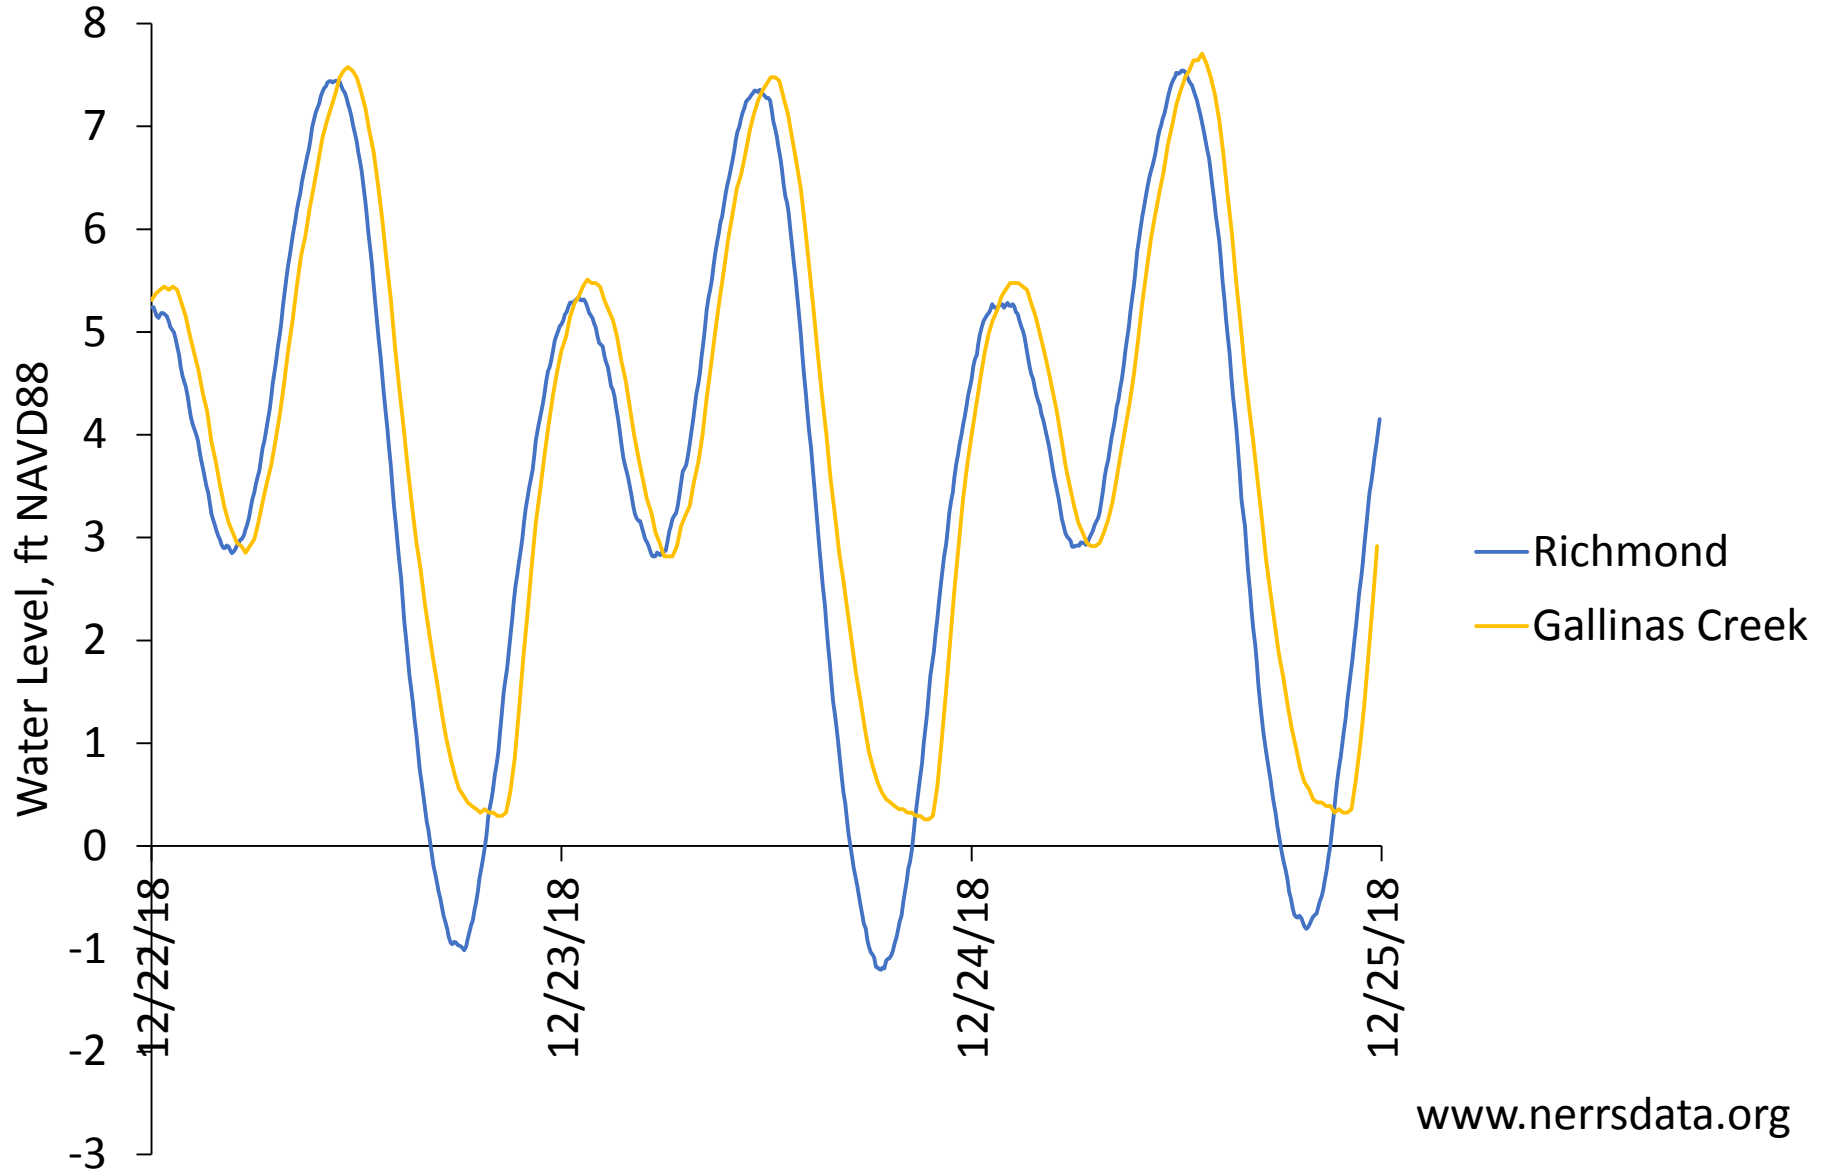
Comparing Water Levels at the NERR Gallinas Creek Station and NOAA Richmond Station

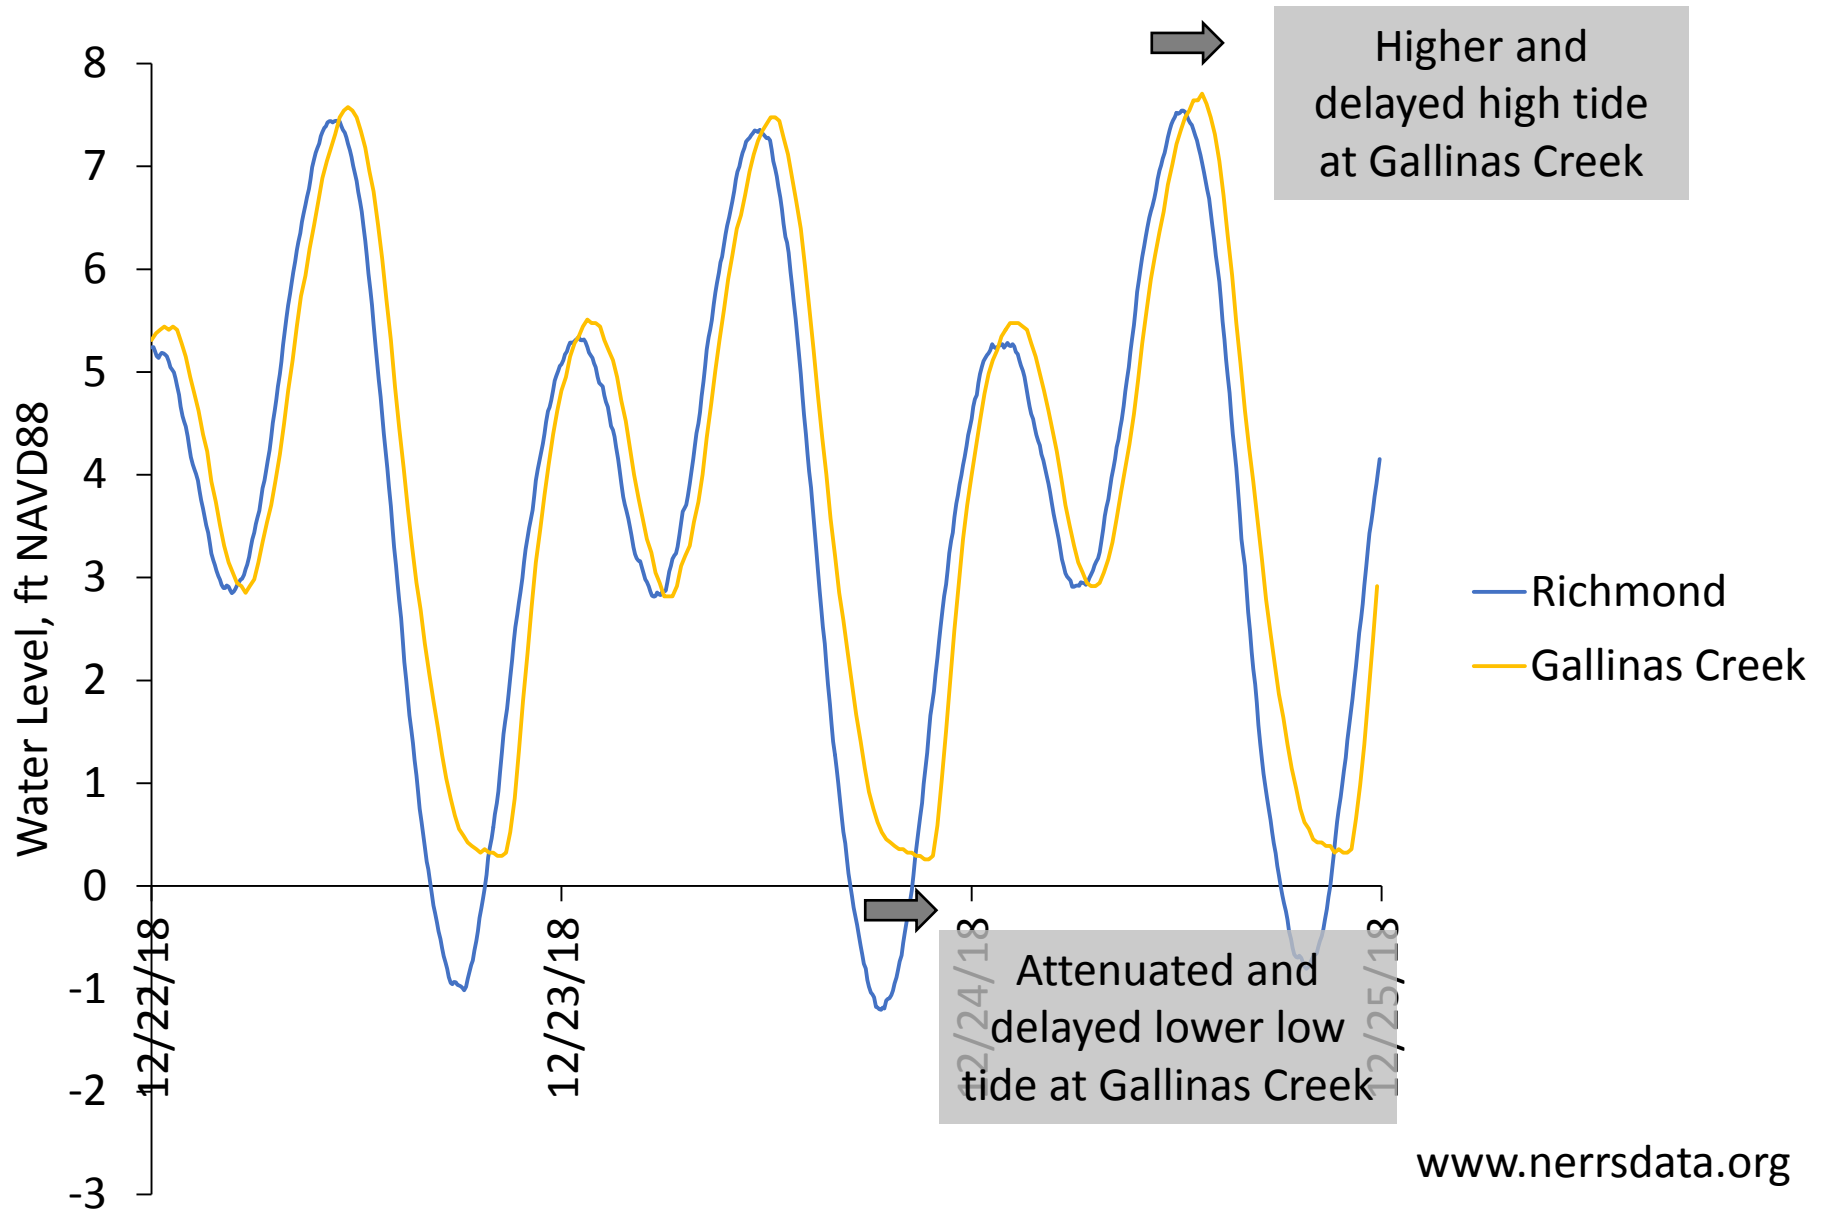
Comparing Water Levels at the NERR Gallinas Creek Station and NOAA Richmond Station

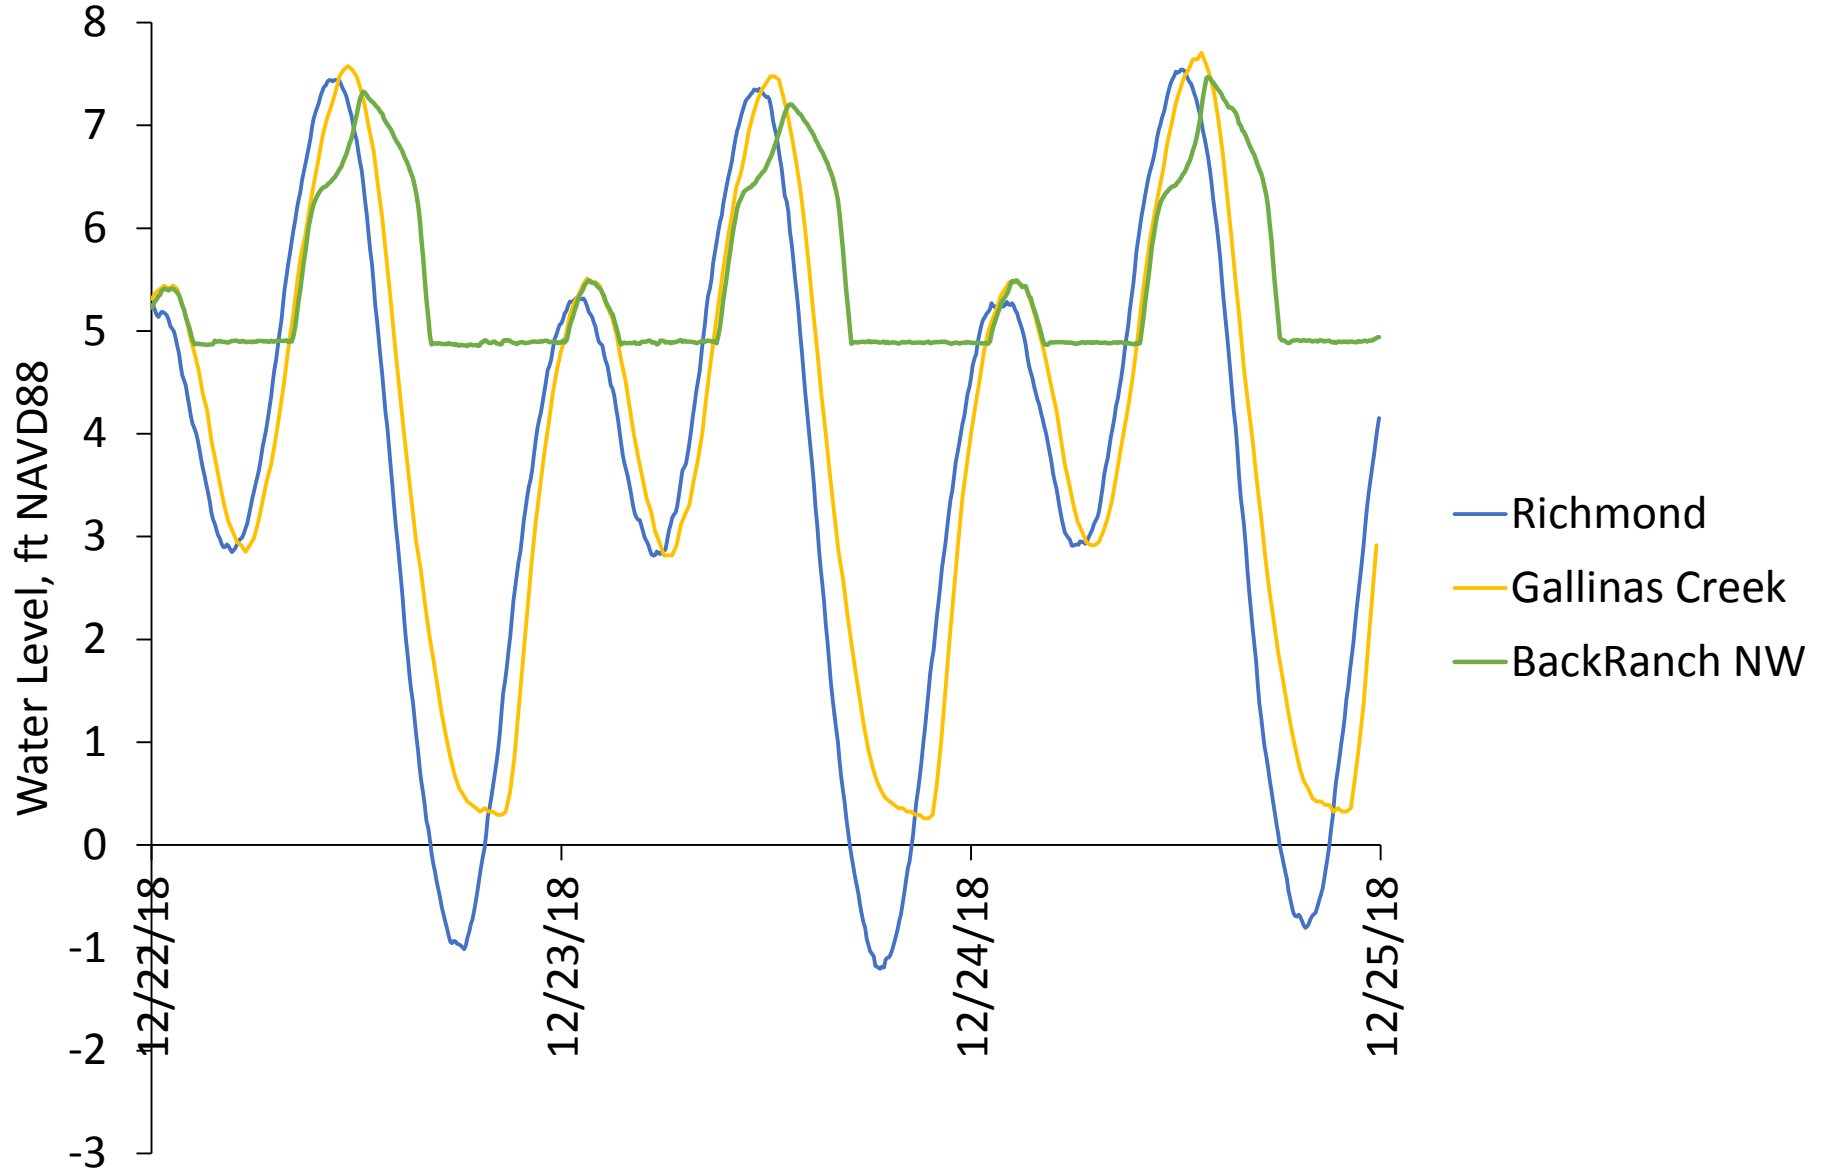
Preliminary water level data from Back Ranch marsh at China Camp State Park

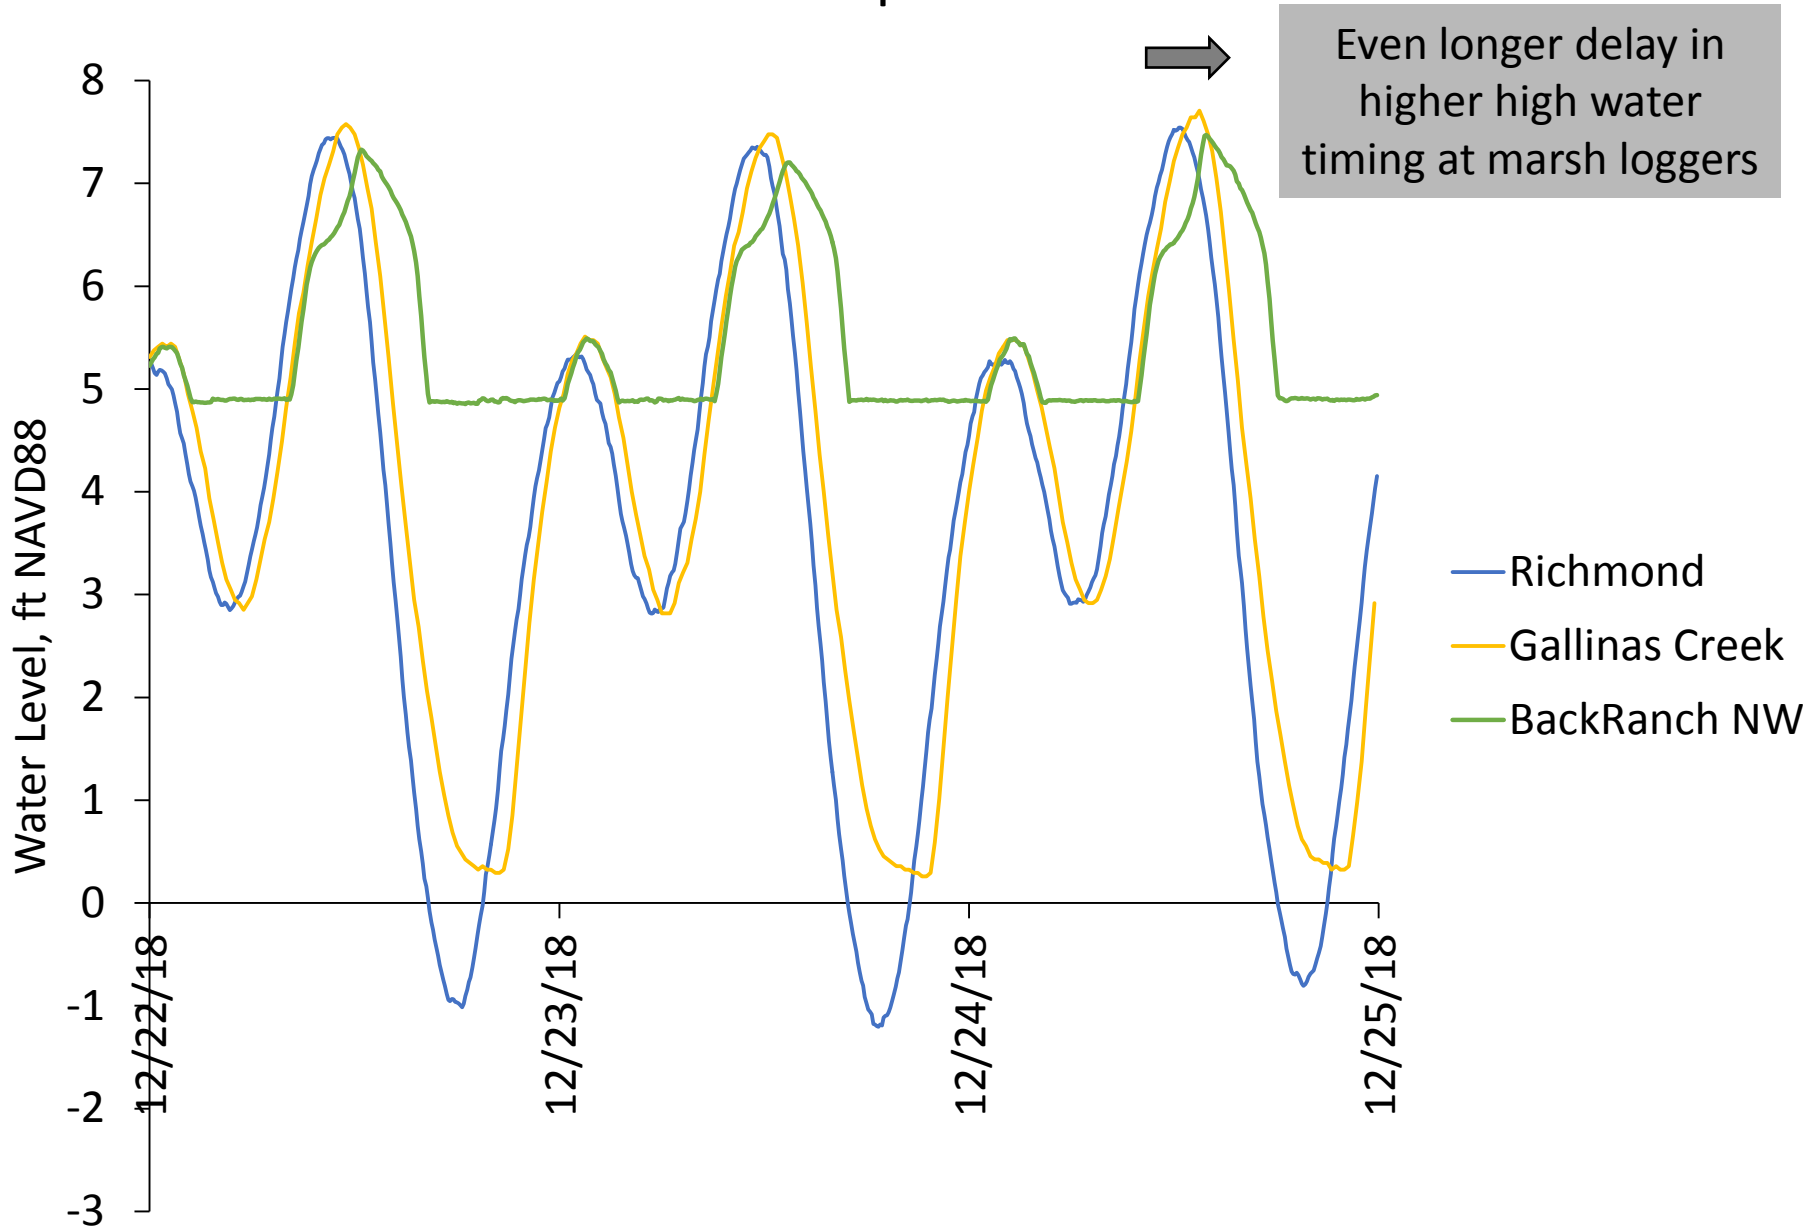
Preliminary water level data from Back Ranch marsh at China Camp State Park

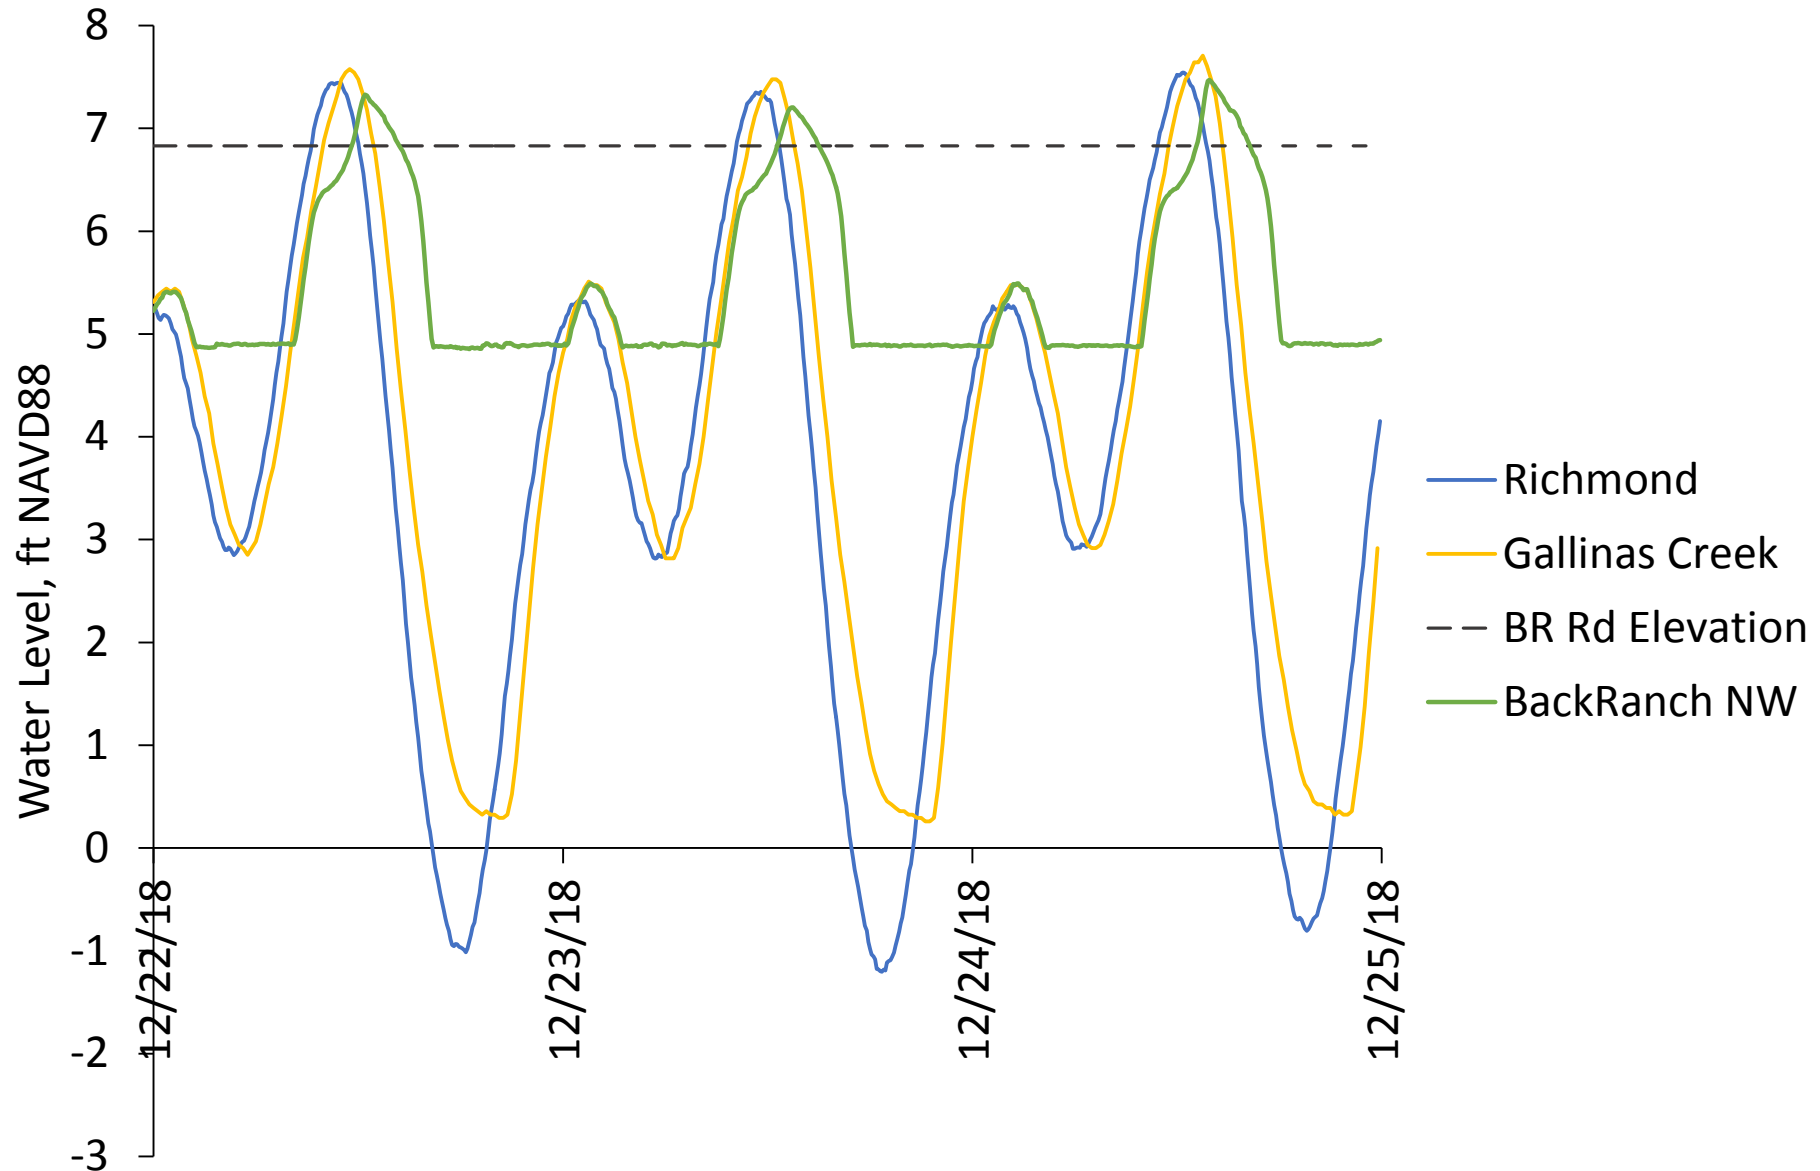
Lowest road elevation at Back Ranch marsh at China Camp State Park

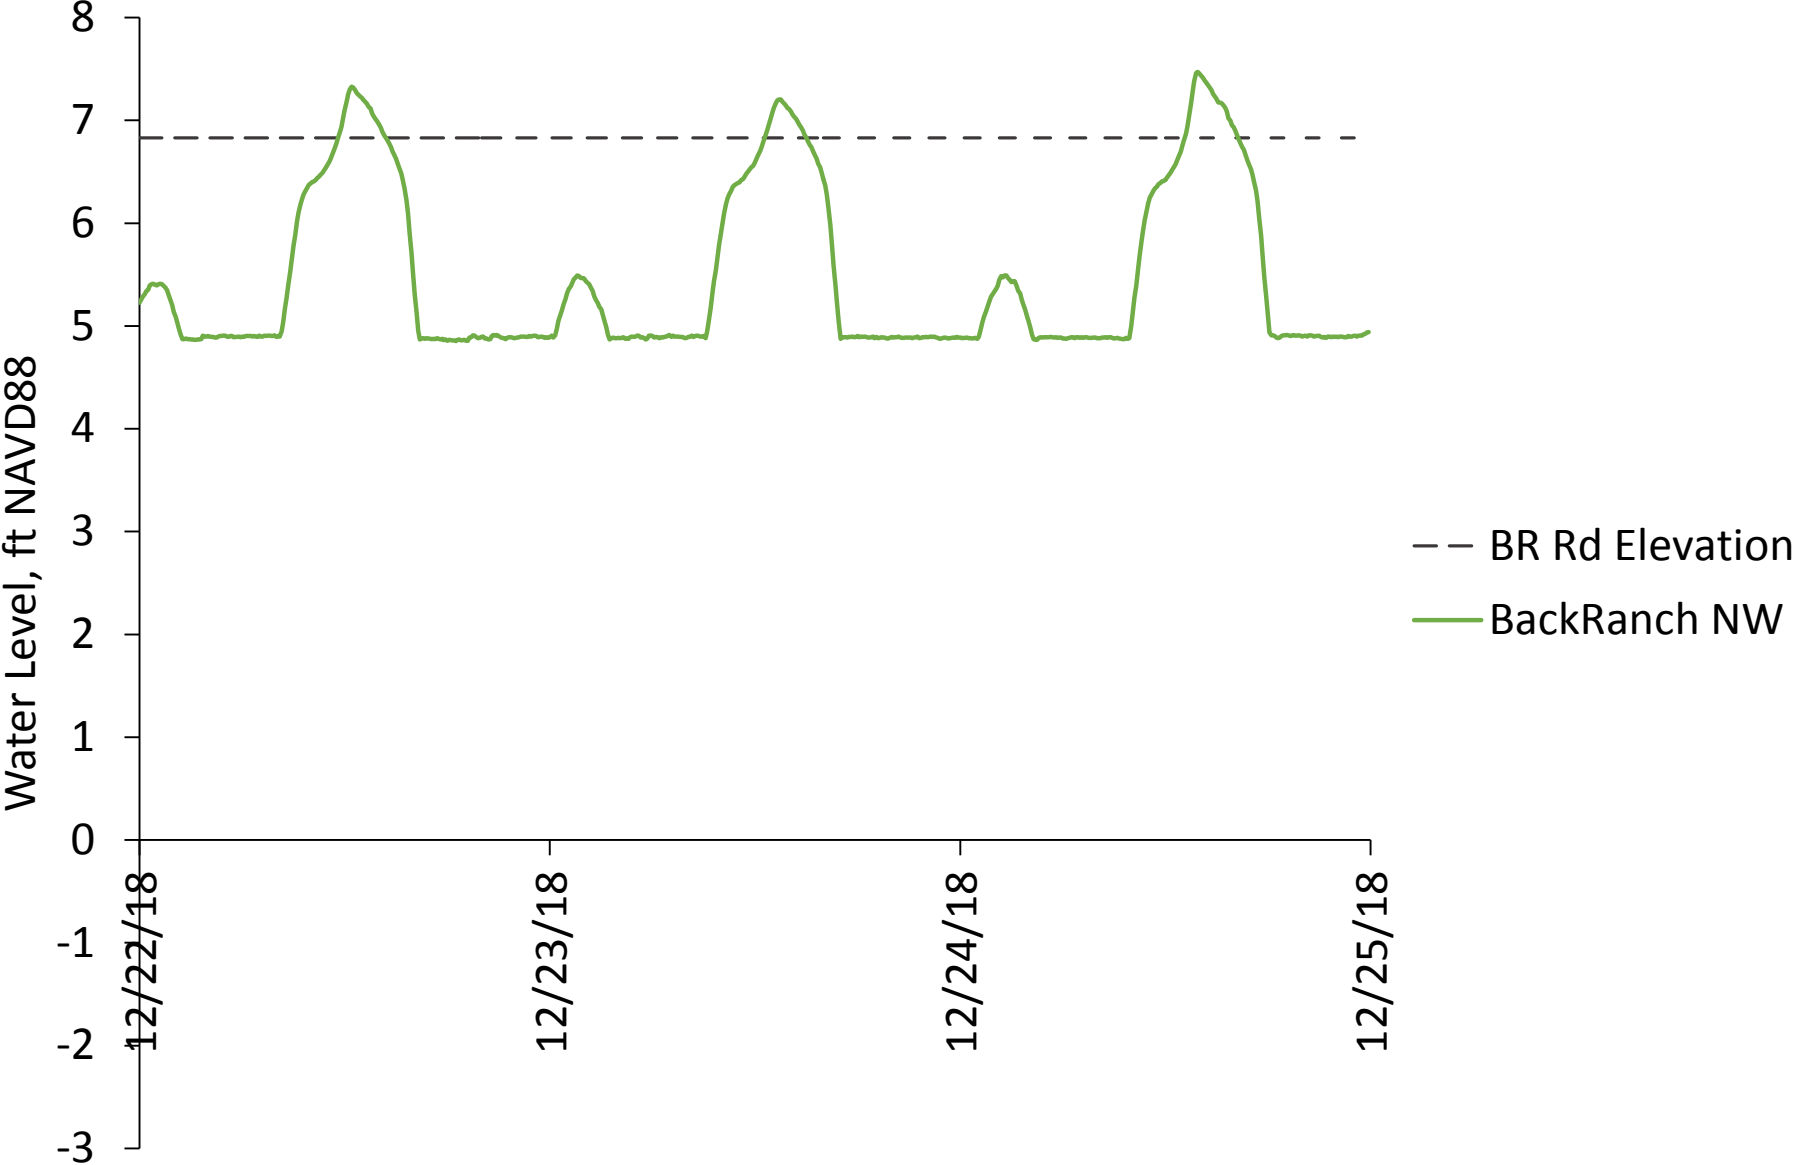
Road flooding during King Tides at Back Ranch marsh in December 2018

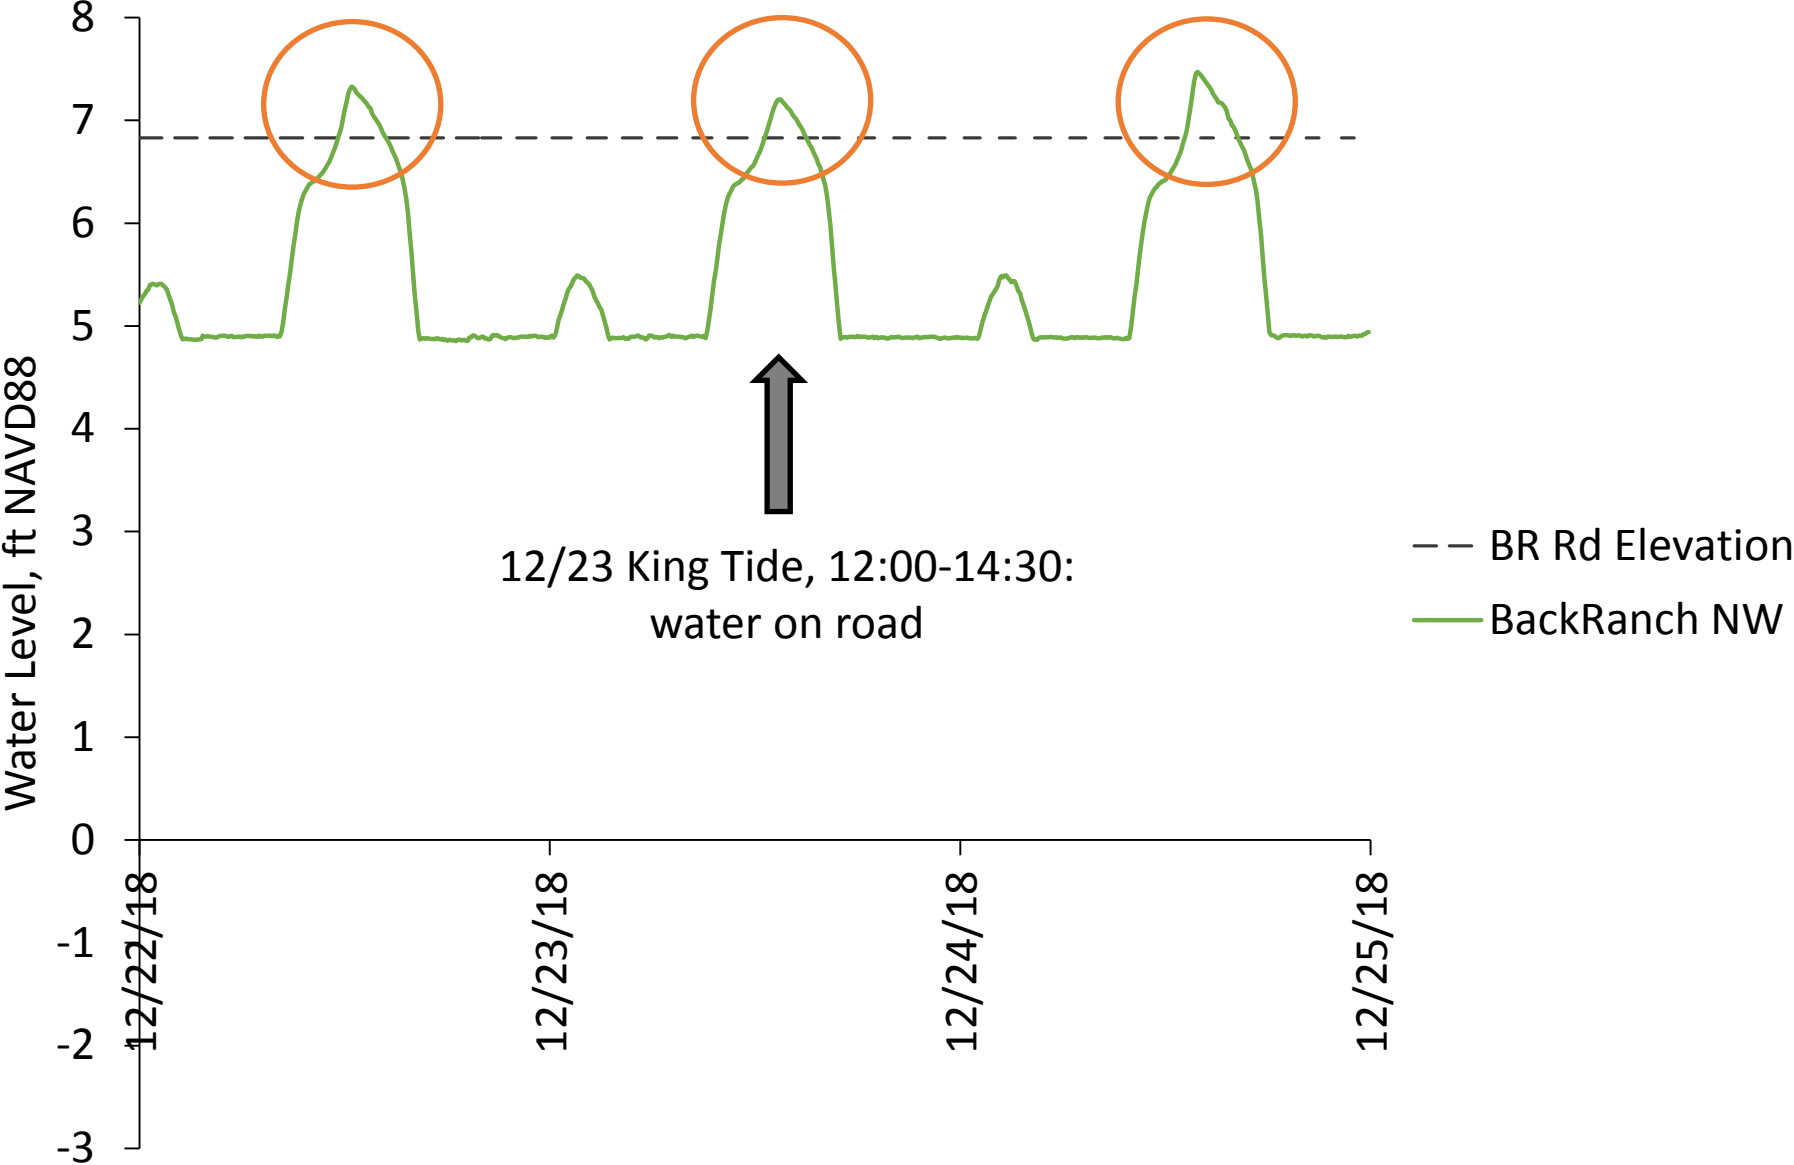
Road flooding during King Tides at Back Ranch marsh in December 2018

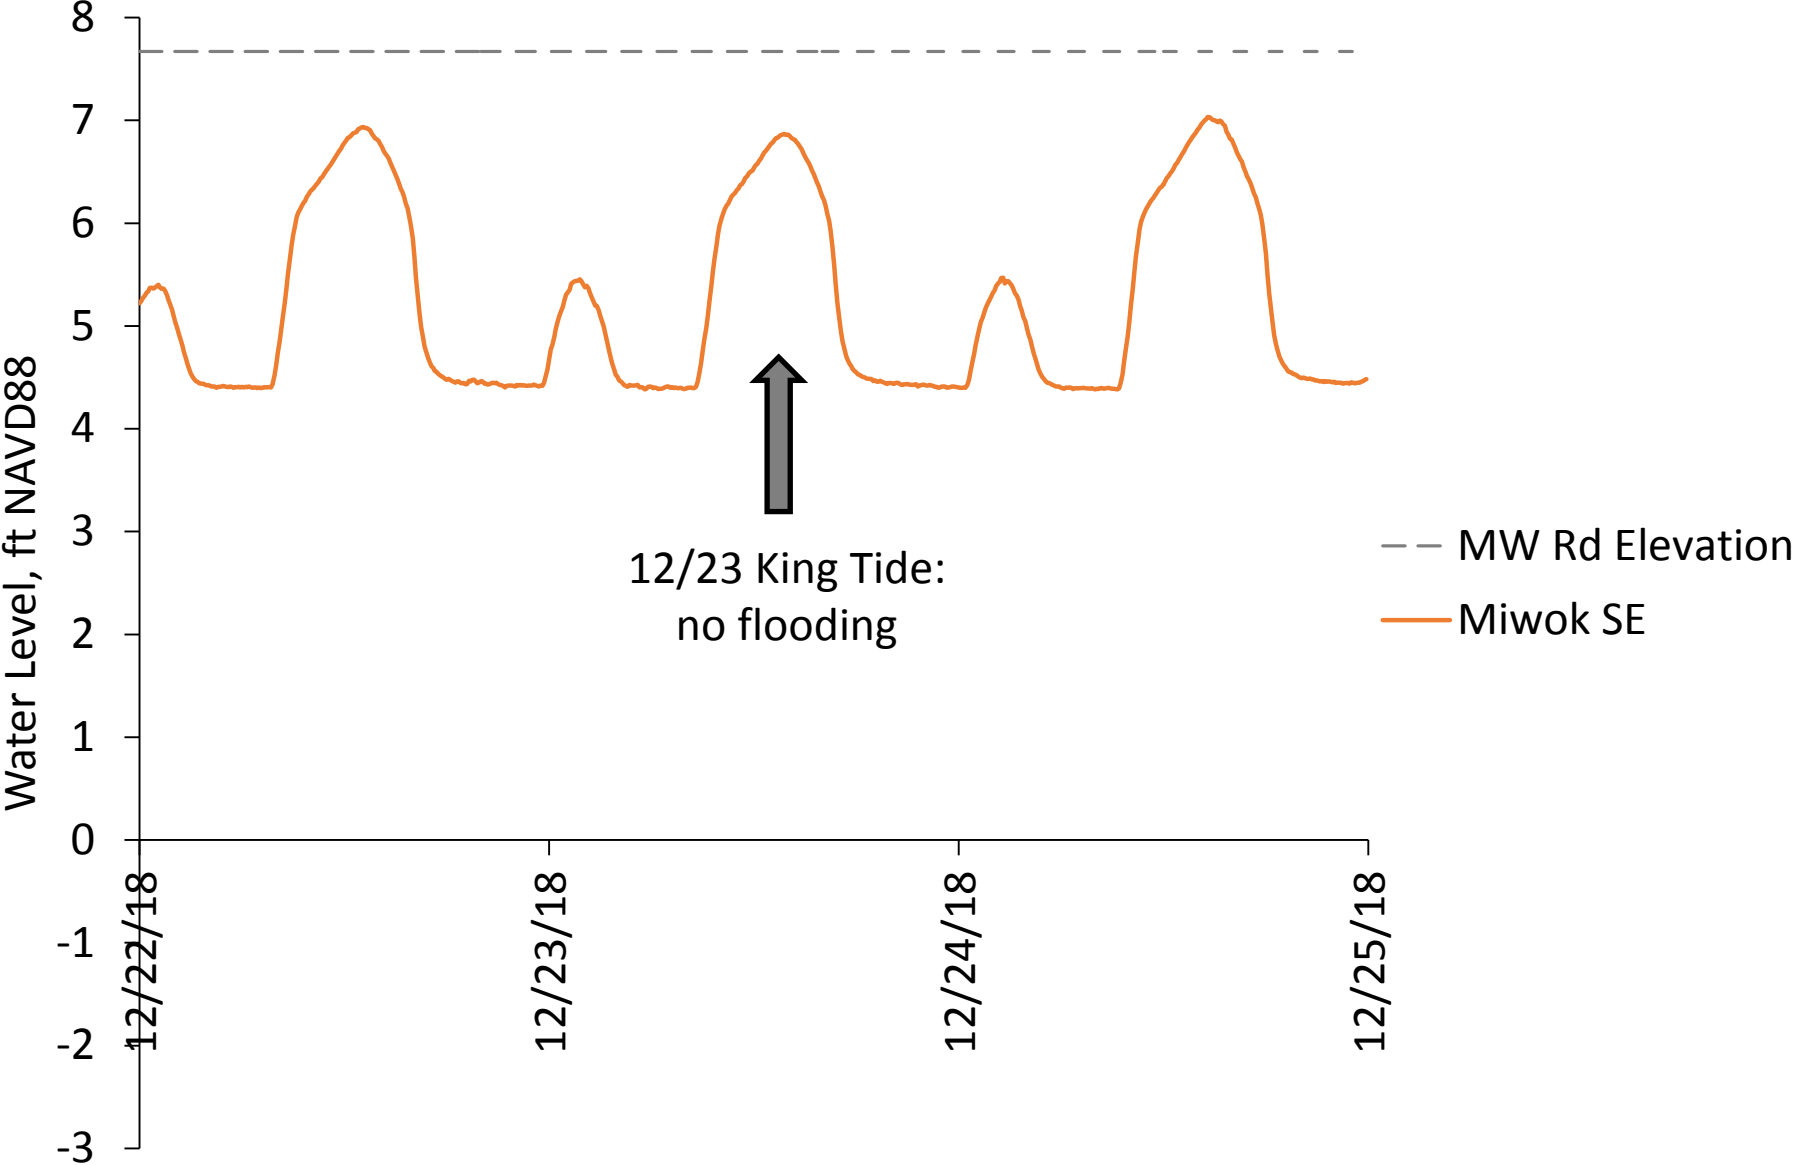
Higher elevation of road at Miwok Meadows marsh has fewer flood events
